**Living Shoreline Sea-Level Resiliency:
Performance and Adaptive Management of
Existing Sites
Summary Report**

Shoreline Studies Program
Virginia Institute of Marine Science
William & Mary

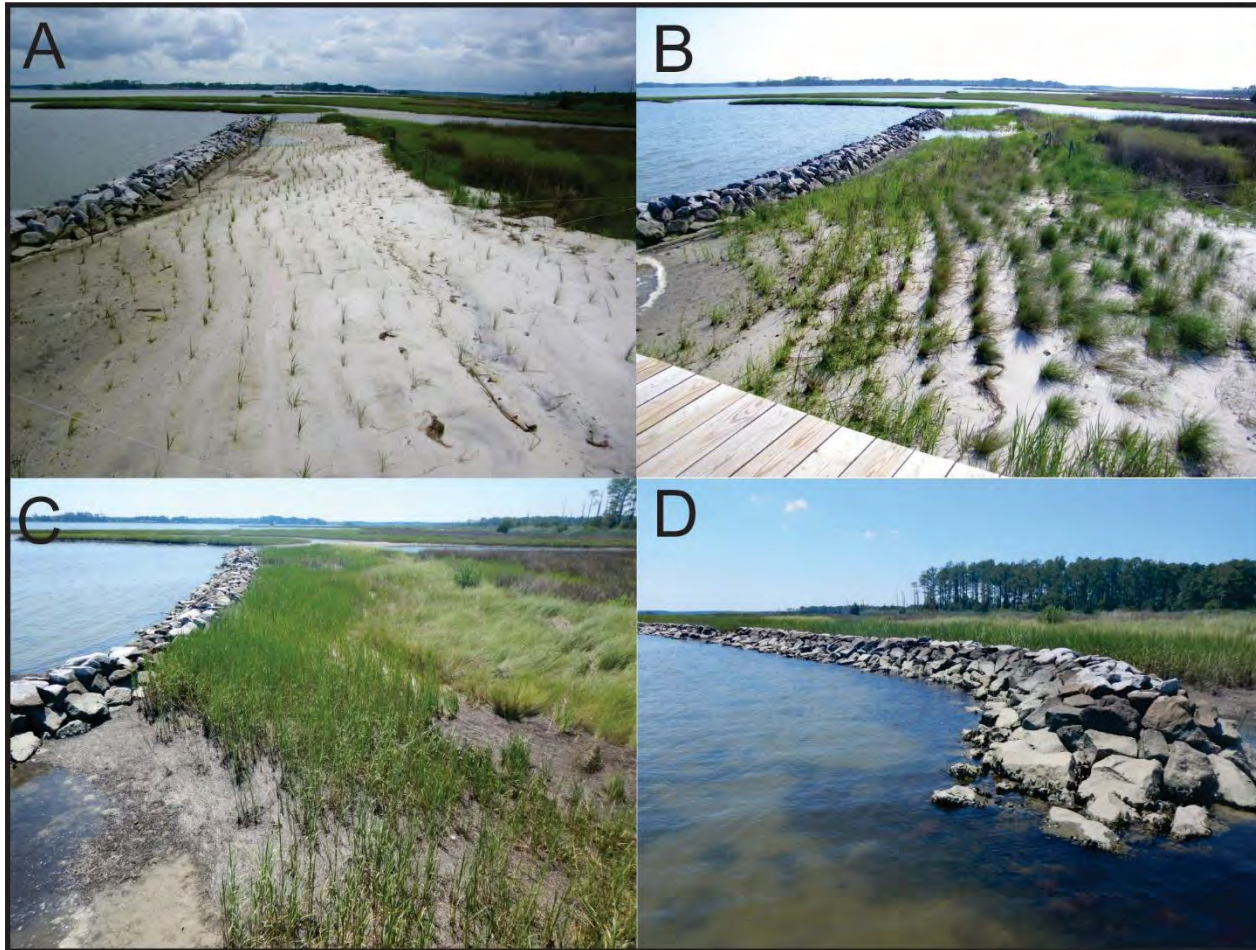
Photos of Captain Sinclair A) Just planted, 2 June 2016; B) One year post planting, 10 May 2017; C) Two years post-planting, 10 July 2018; D) Oysters line the rock sill shown at low water, 10 July 2018. Photo credit: Shoreline Studies Program.

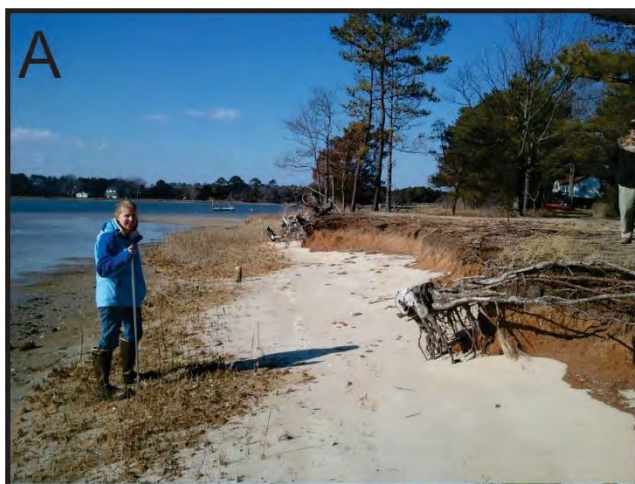
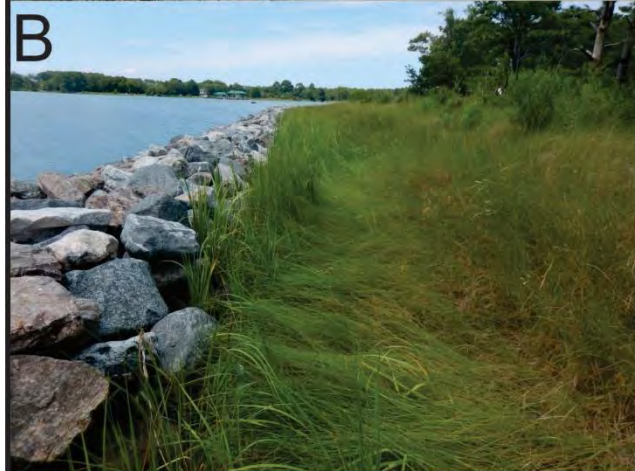
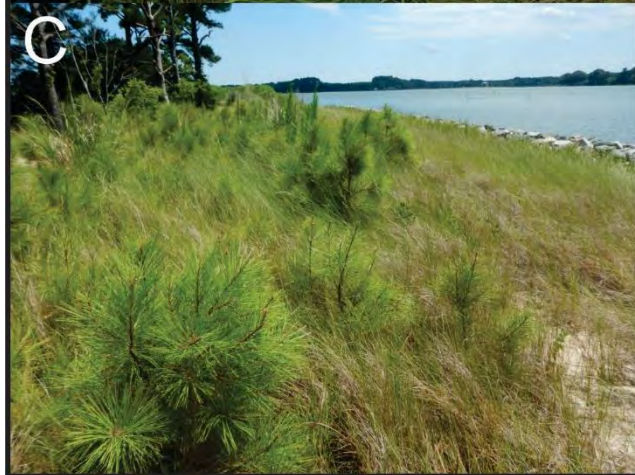
Photos of reach 1 at
Occohannock on the Bay A) before
installation (April 2013),

B) after 5years (July 2018),

C) after 5 years, the
backshore is being colonized by trees.

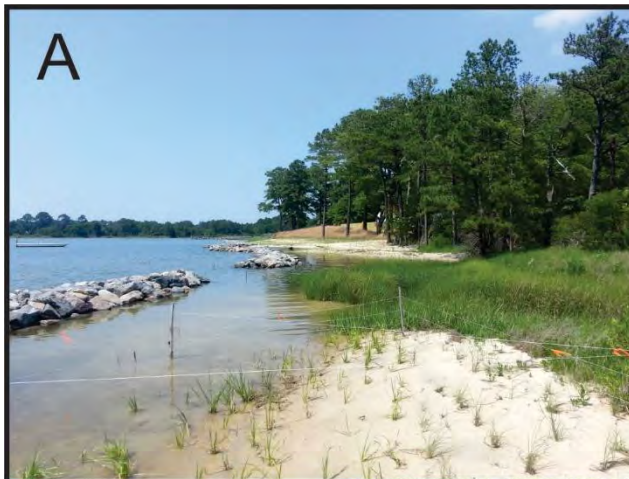
Photos of reach 2 at Occohannock on the Bay A) after planting (May 2013),

B) after 5 years(July 2018),

C) after 5 years there is abundant oyster growth around the end and outside of the rock sills.

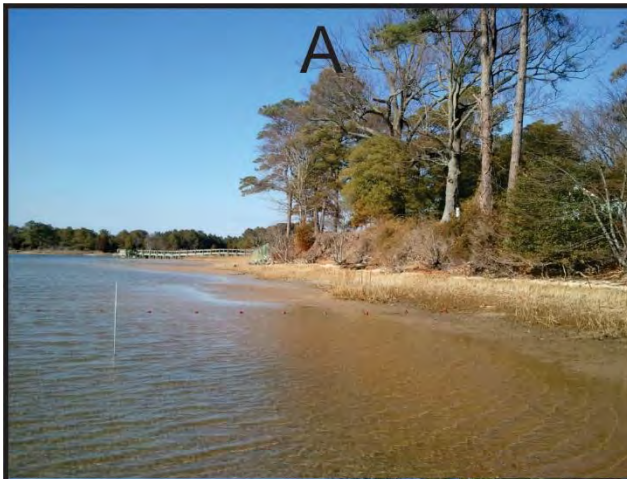
Photos of reach 3 at Occohannock on the Bay A), before construction (March 2013),

B) After planting (May 2013),

C) after 5 years.

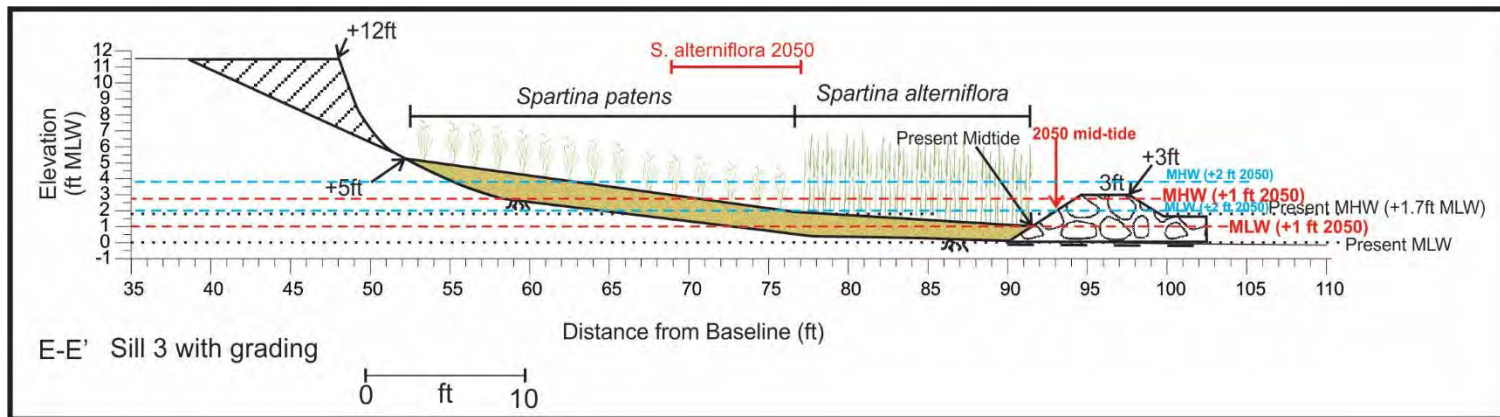
Sea-level rise scenarios modeled at Occhohannock. Also shown is the adaptive management strategy coastal resiliency of the living shoreline. Rock and sand could be added to the system to “reset” it thereby protecting the base of the bank.

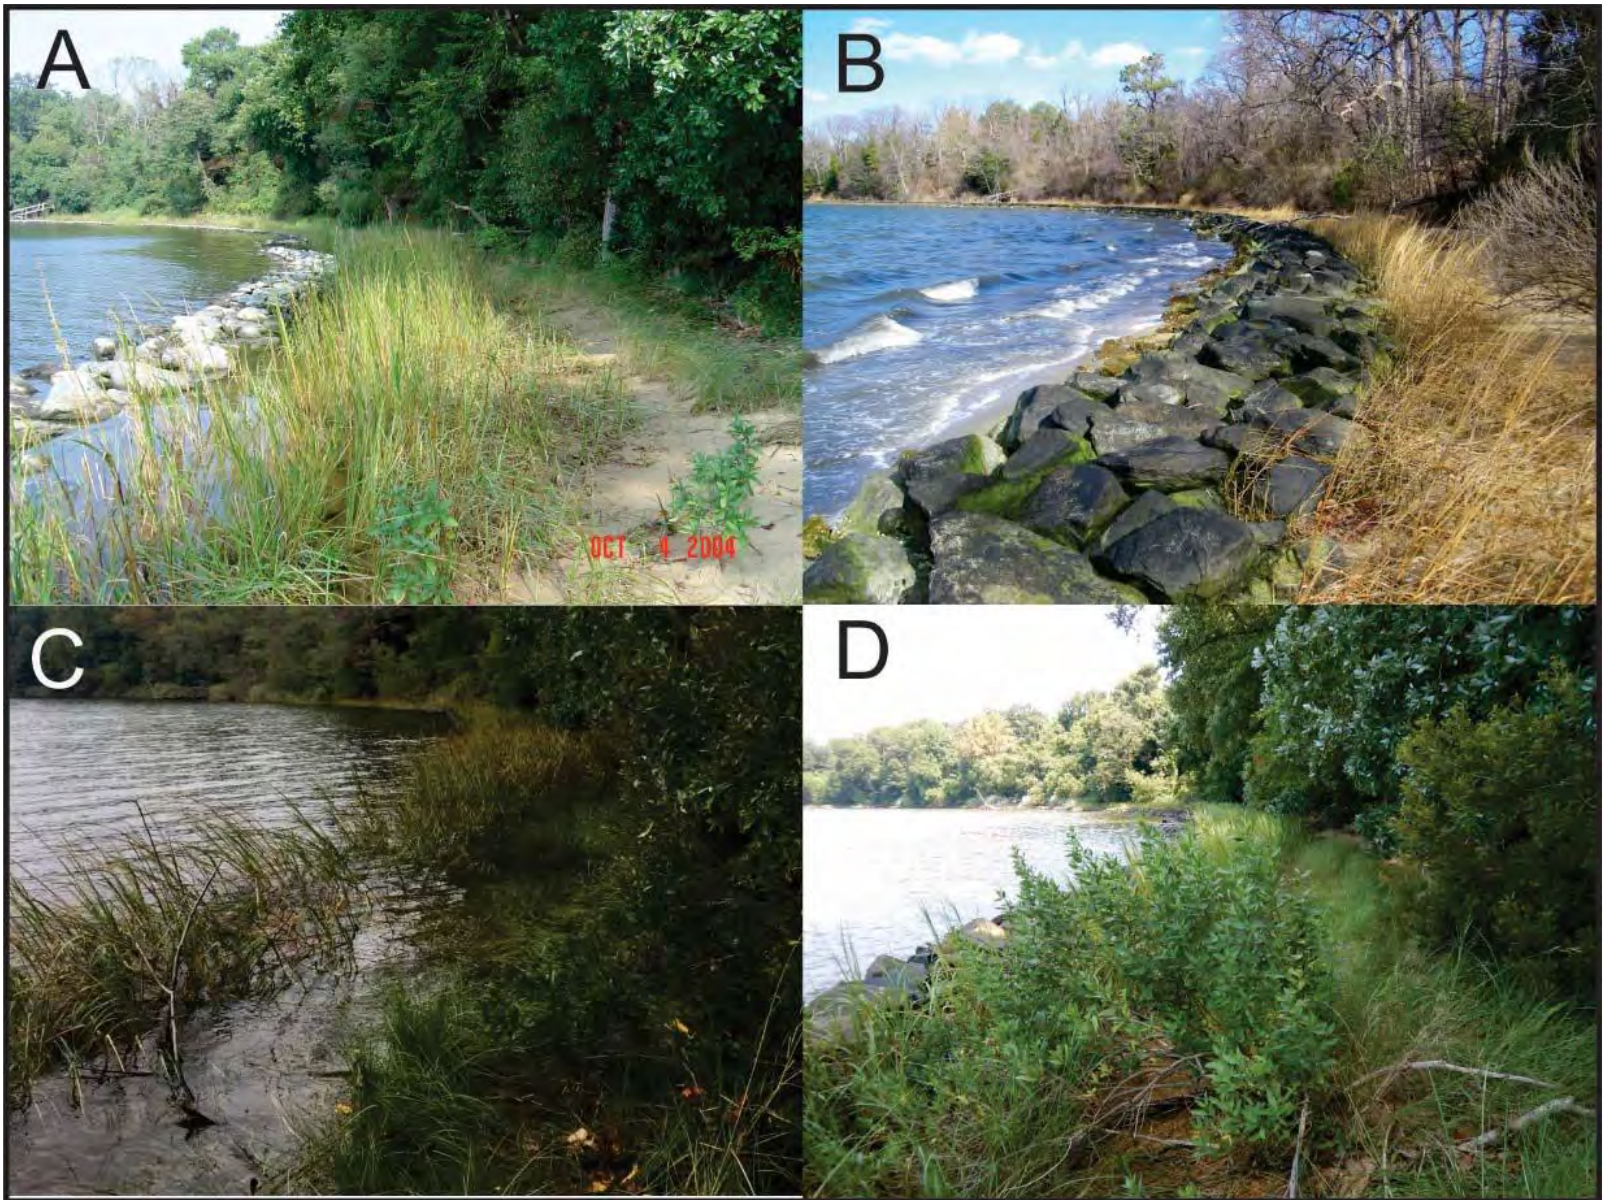
Photos of St. Mary's, South end: **A**) two years after construction (4 Oct 2004), **B**) 11 years after construction (1 Feb 2013), **C**) 15 years after construction (13 Oct 2017), **D**) 16 years after construction (15 Aug 2018).

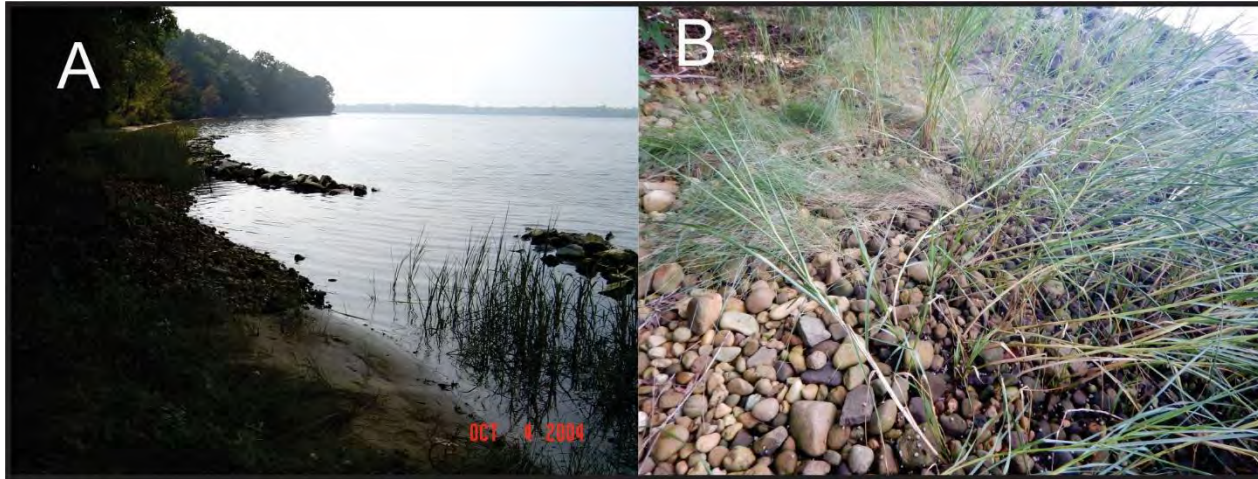
Gap at St. Mary's with Cobble pavement A) two years after construction, B) 16 years after construction (15 Aug 2018)

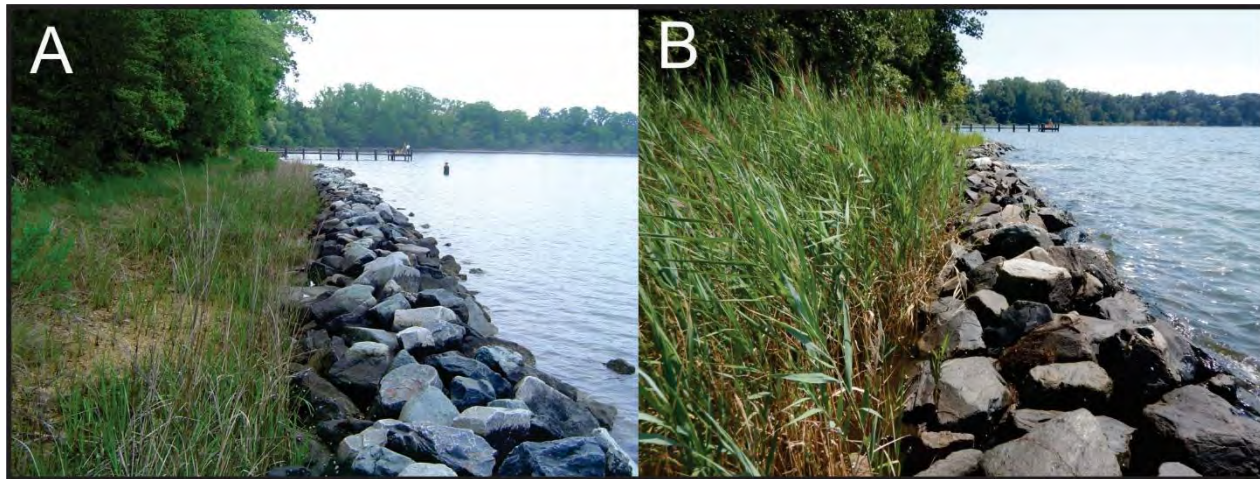
Sill at St. Mary's A) five years after construction (9 May 2007), B) 16 years after construction (15 Aug 2018). Phragmites has colonized behind the structures.

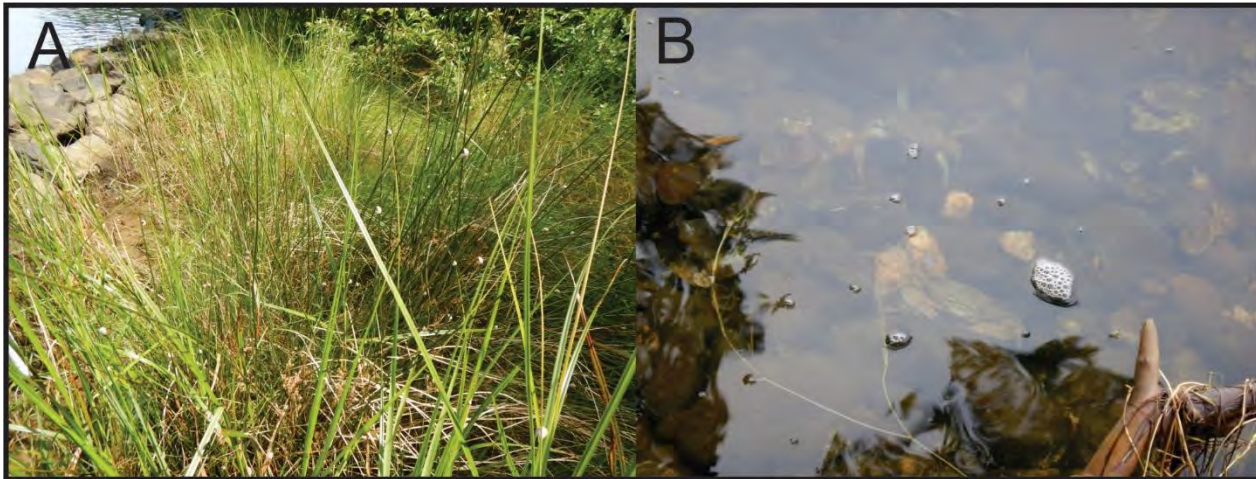
Sill at St. Mary's (15 Aug 2018) A) Needlerush has colonized some sections, B) blue crabs are prevalent along the shore.

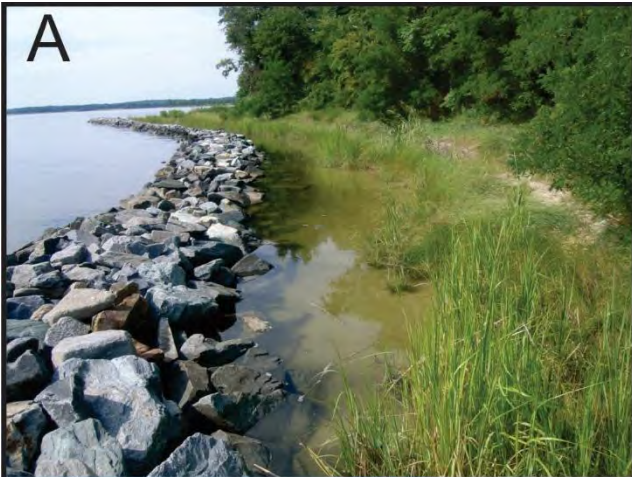
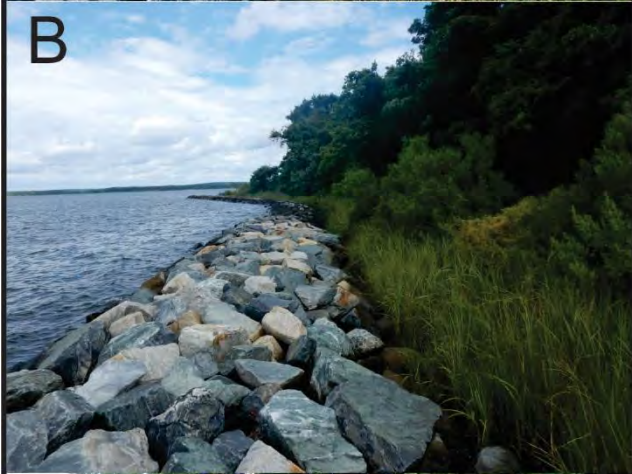
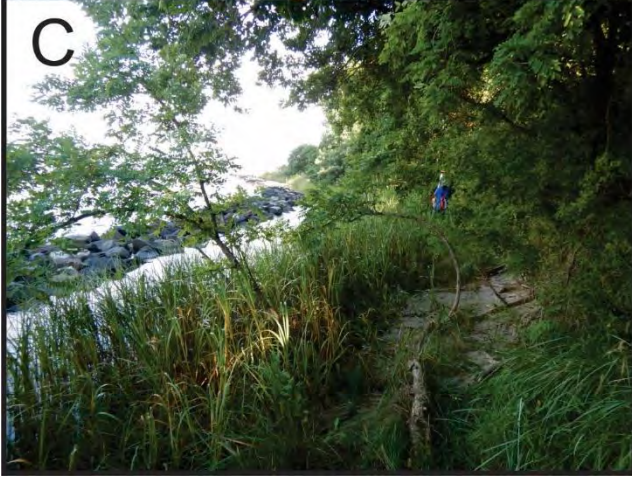
Photos of Sill #4 at Jefferson
Patterson on 20 Aug 2018 A) along the low
weir section,

B) higher section of sill,

C) along
the backshore.

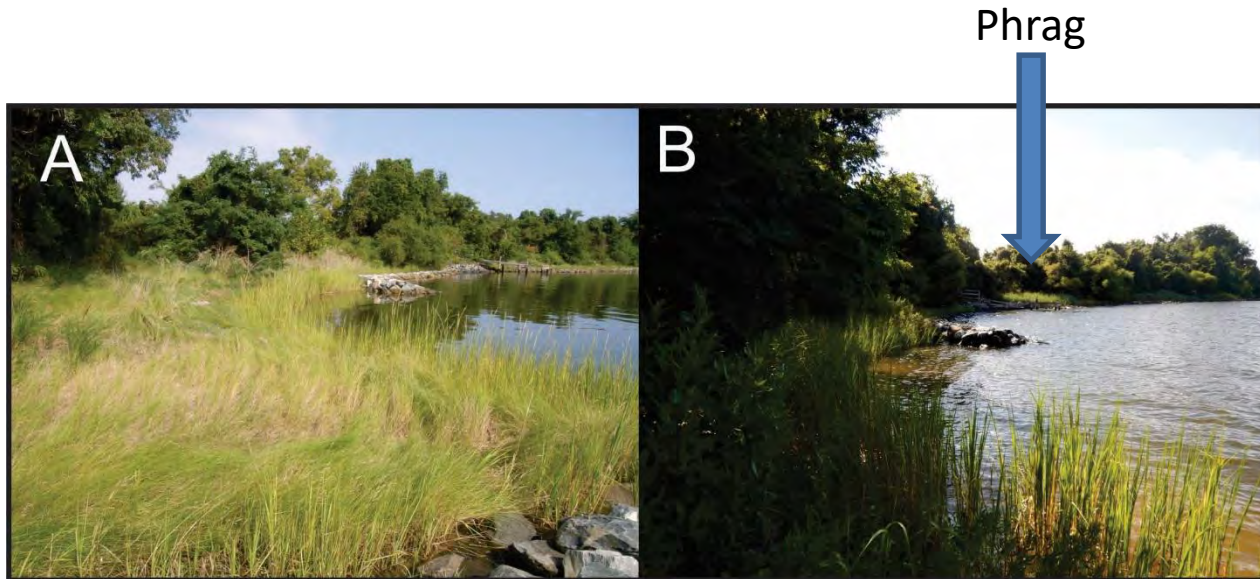
Photos at Jefferson Patterson looking from sill #4 downriver toward sill #3-3 in
A) 2008 and B) 2018 where extensive Phragmites is visible.

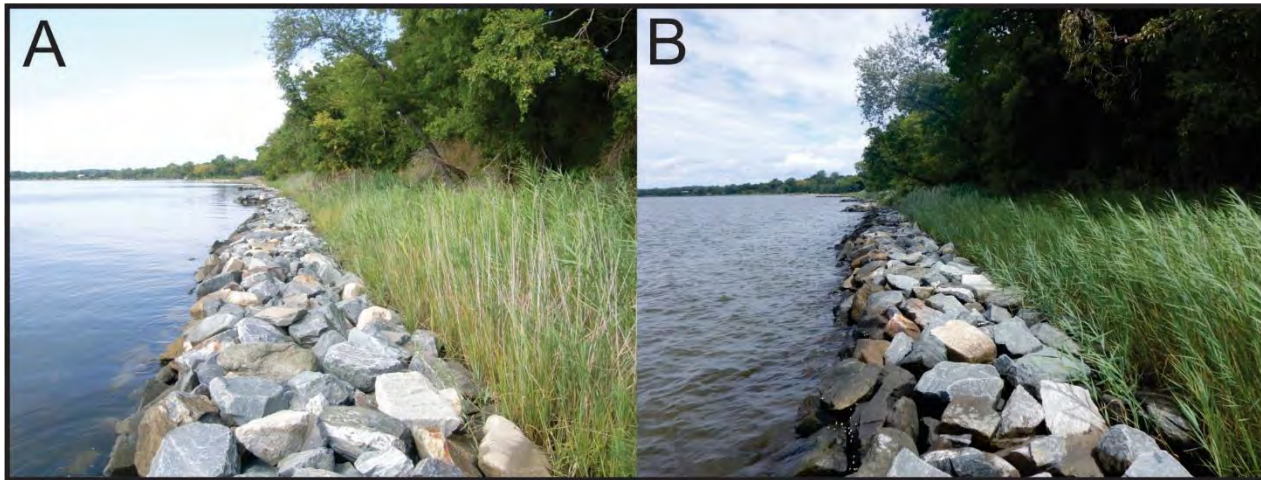
Photos at Jefferson Patterson looking from sill #5-1 and beyond in A) 2008 and B) 2018 where extensive Phragmites is visible.

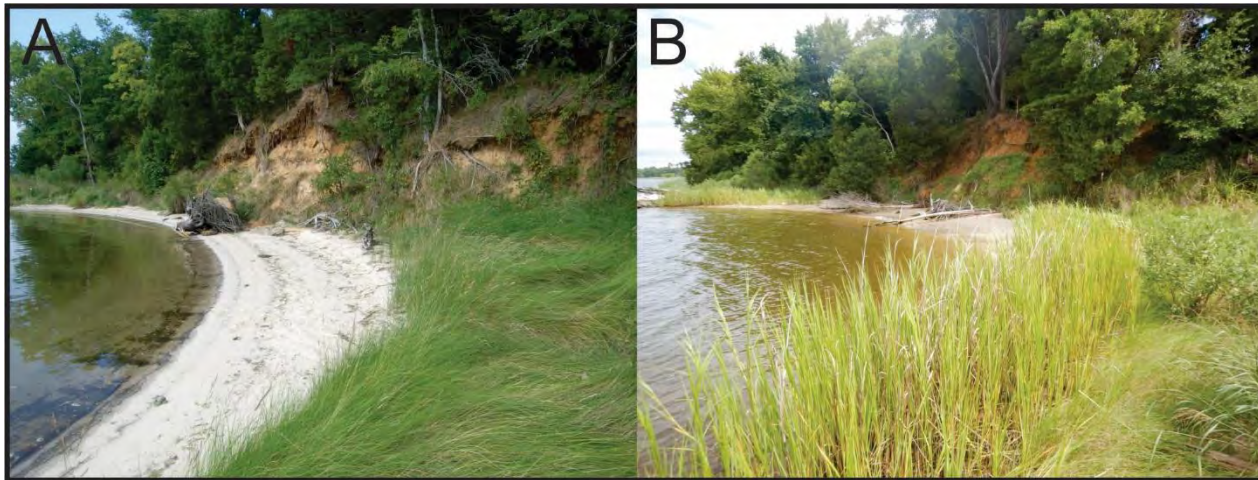
Photos at Jefferson Patterson of the embayment between BW4 and Sill 5-1 in A) 2008 and B) 2018 where Phragmites is visible and beach has narrowed with continued bank sloughing.
