Living Shoreline Professionals Advanced Training

Virginia Institute of Marine Science
College of William & Mary

**LIVING SHORELINE PROFESSIONALS
ADVANCED TRAINING
AUGUST 2017**

**DESIGN GUIDELINES FOR
MARSH SILLS & OFFSHORE BREAKWATERS**

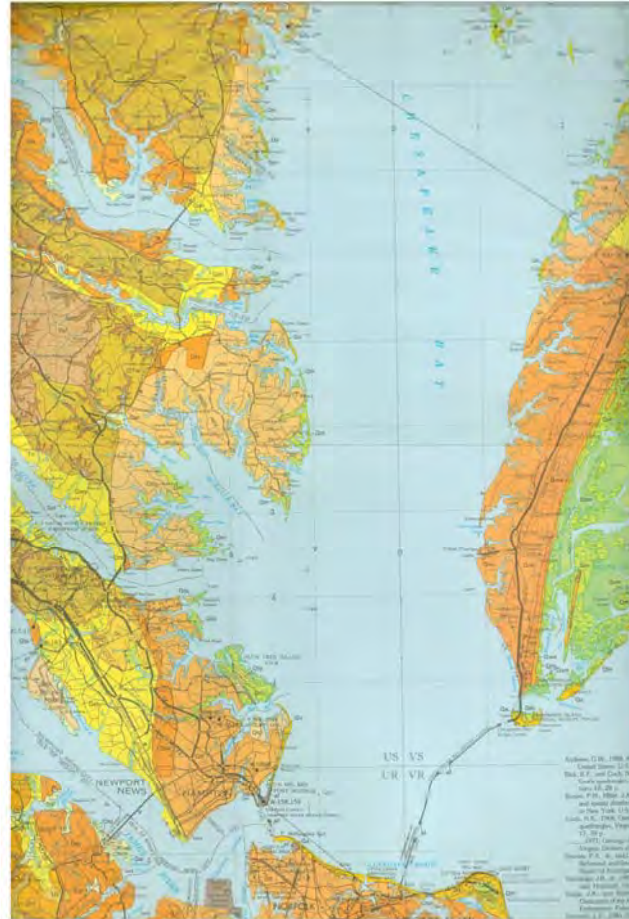
Virginia Coastal Plain Geology

The underlying geology of a site is important because it determines such things as bank height, sediment type, and resistance to erosion.

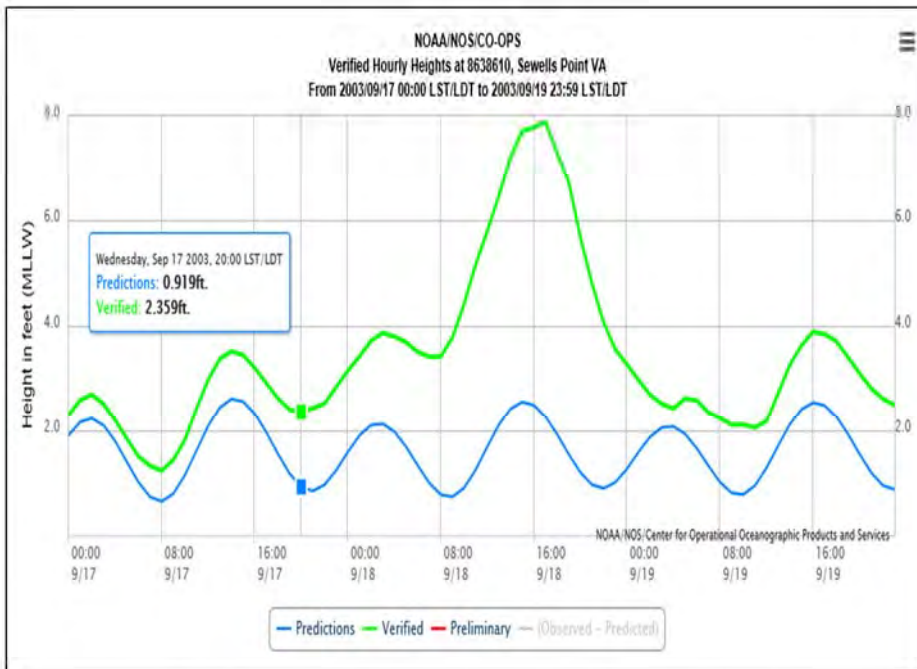
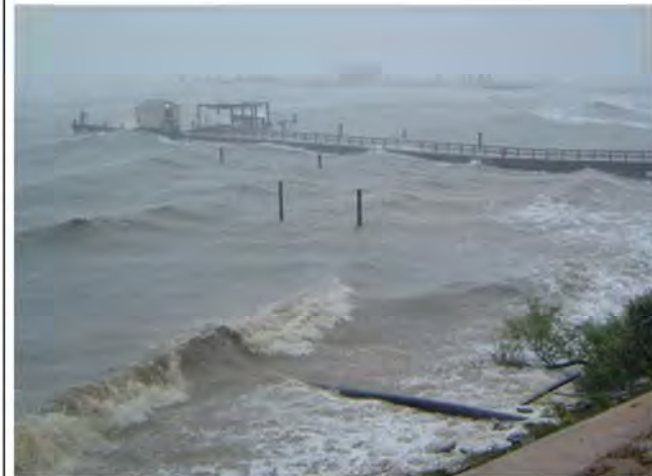
Storm Surge Sewell's Point: Isabel

The historic maximum water elevation likely to impact a site can be used to determine the level of protection needed.
tidesandcurrents.noaa.gov

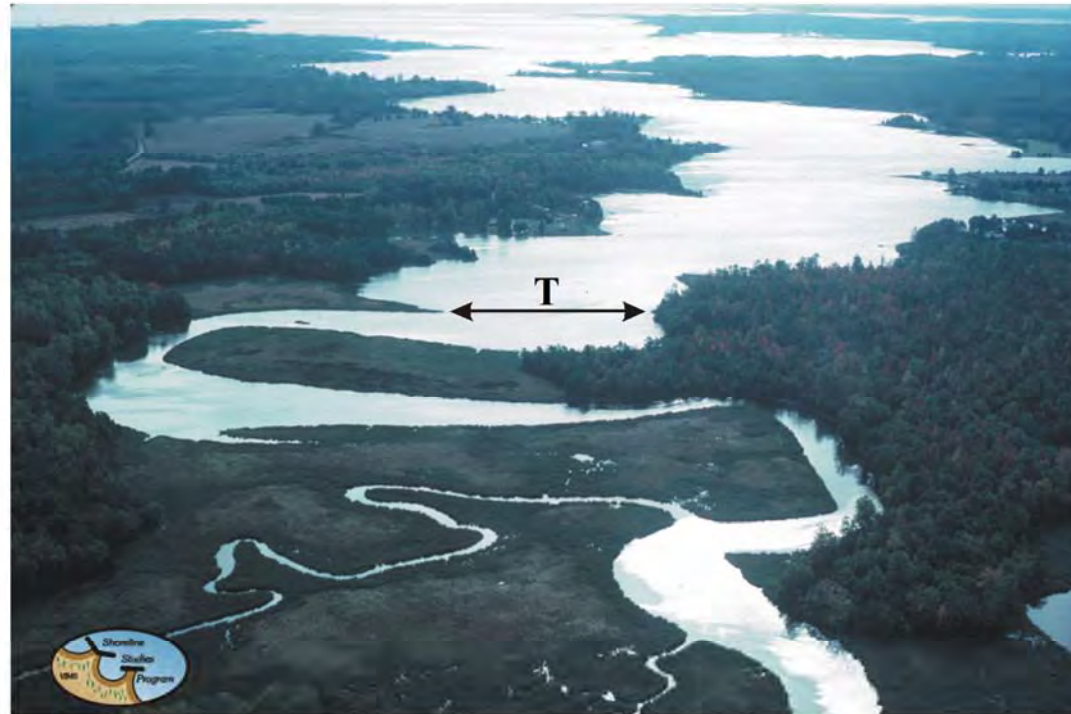
Broad marshes in foreground give way to fringing marshes downstream where there is greater fetch exposure. At the transition point (T), shoreline processes go from tidally dominated to wave dominated (Ware River, Virginia).

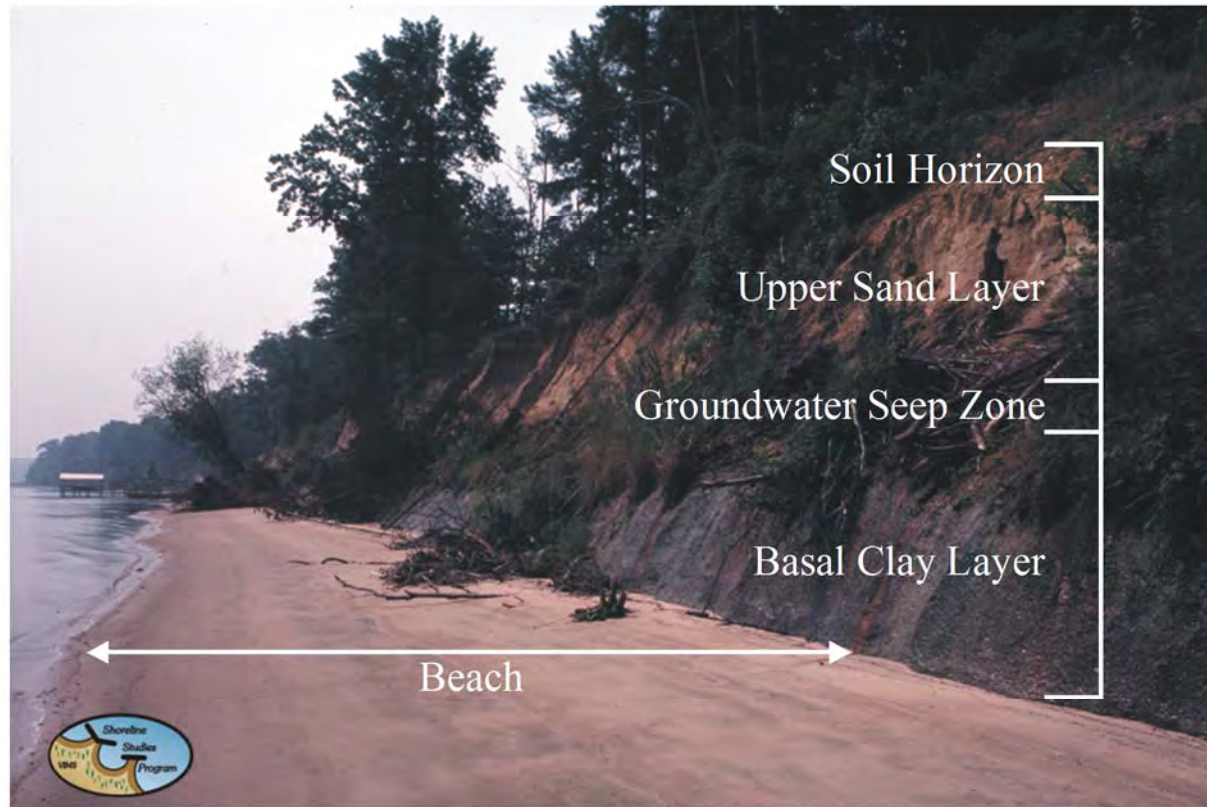
Exposed and eroding upland banks along the Rappahannock River, Virginia. Note: Basal clay acts as a groundwater perch causing the upper layer of sand to slump.

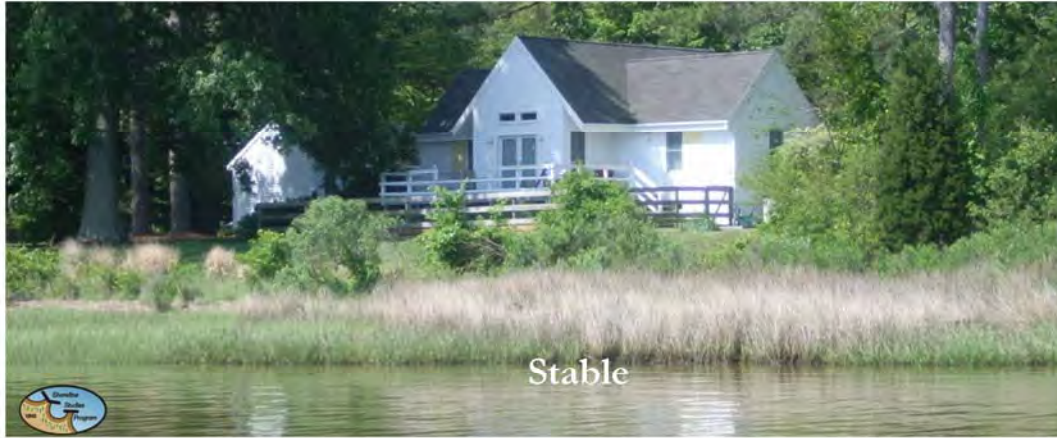
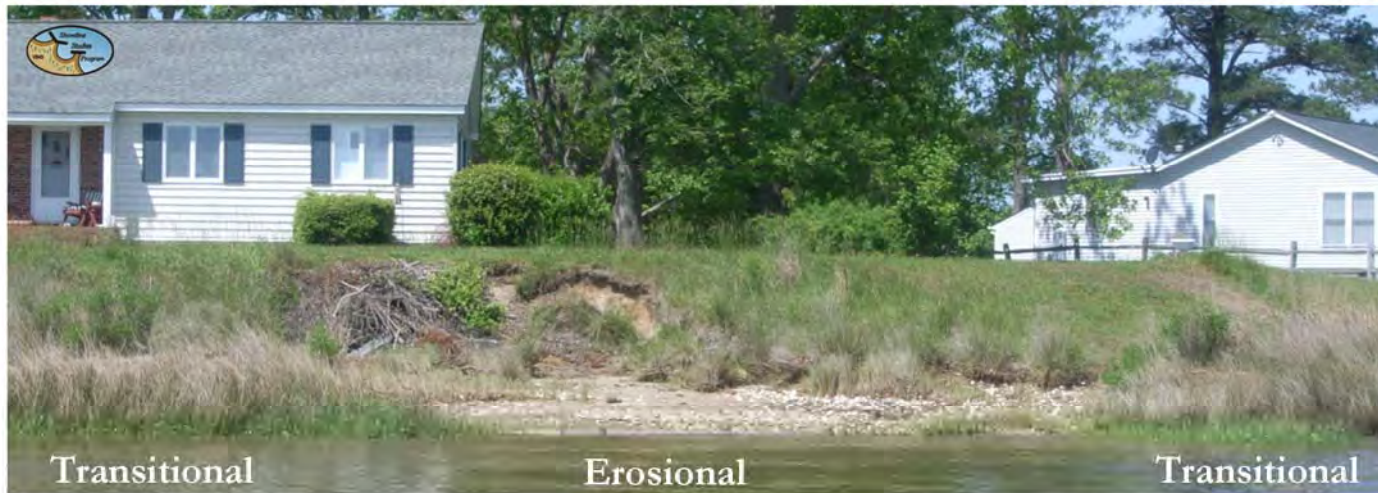
Photos indicating different conditions for low banks. A stable bank has a wide marsh and vegetated bank.

The erosional bank has no marsh and a scarp bank. The transitional bank does not have an actively eroding bank, but the narrow fringe marsh in front is eroding. The bank may be impacted under storm conditions. Once the marsh is entirely gone, it will become an erosional bank.

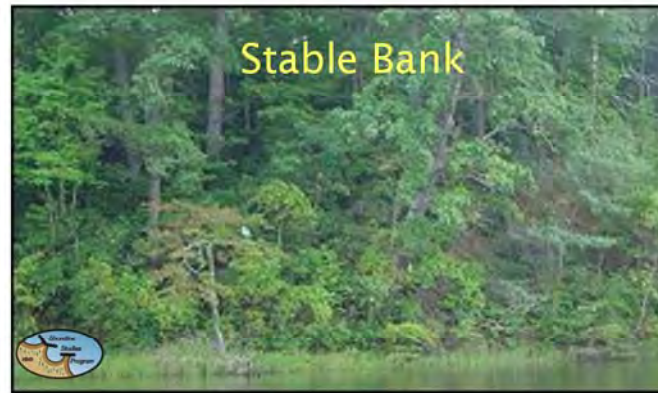
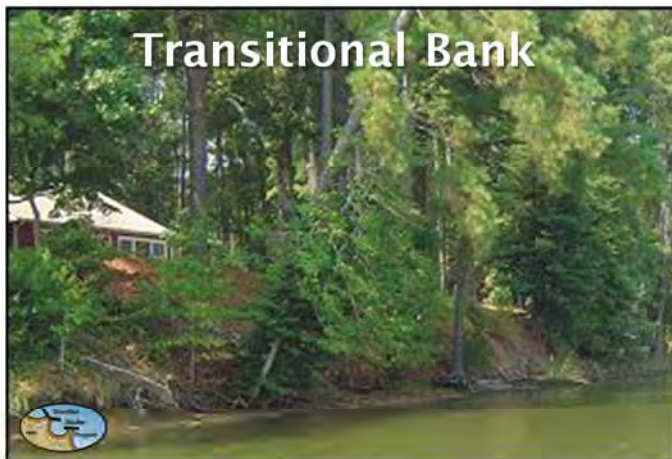
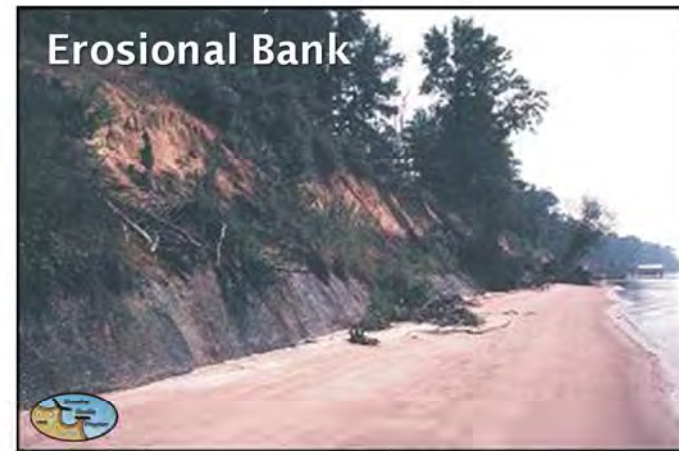
Photos indicating different conditions for higher banks. A stable bank has a marsh and vegetated bank.

The erosional bank has a beach created primarily from material eroded from the bank. The transitional bank may be undercut with little or no marsh present. The marsh fringe is entirely gone, it will become an erosional bank.

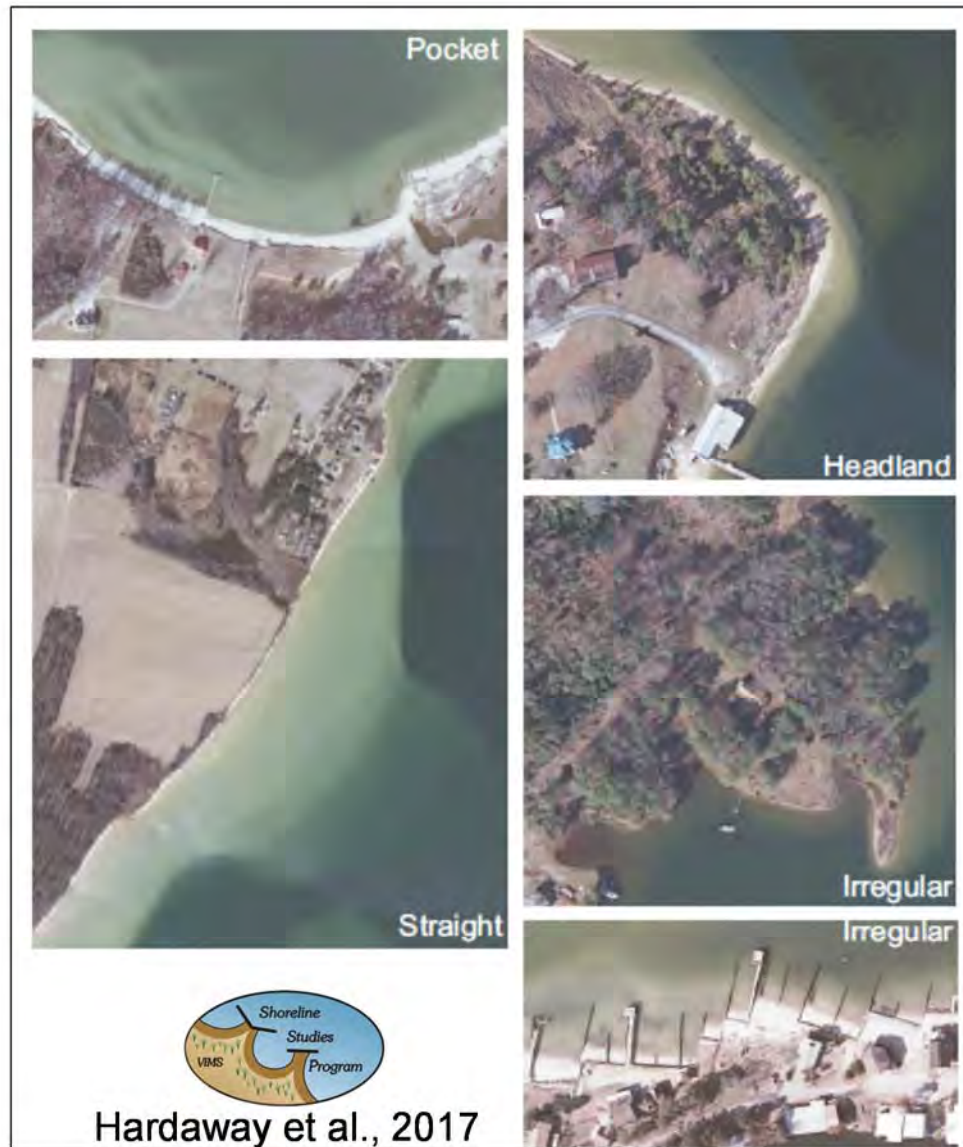
Shore Morphology

Shore morphology is an important consideration in shore protection design because certain shore types, such as pocket or embayed, provide protection themselves. Open, straight shorelines tend to receive the full impact of waves, and irregular shorelines can break up the wave crests along its length, reducing impacts. Also, little sand may be transported around a major headland, creek mouth, tidal inlet, or major change in orientation.

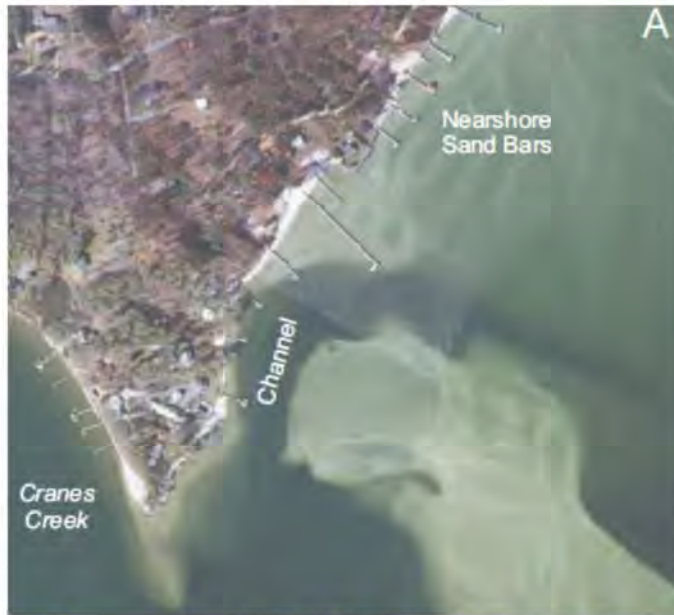
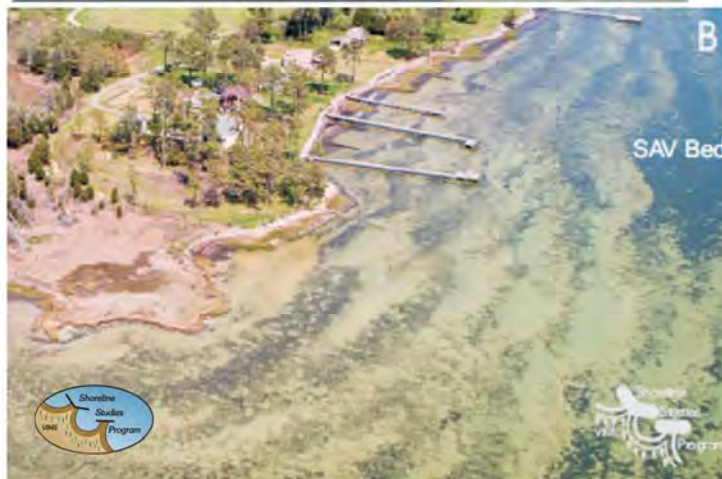
Nearshore Morphology and Stability

Top: Sand bars north of the channel will attenuate waves while the shoreline adjacent to the channel has no bars and will feel the full effect of the waves impacting the shoreline.

Bottom: SAV and sand bars in the nearshore will attenuate waves.

Sand flats indicated sand is available to the overall system and generally mean that the bottom is stable enough to hold a structure.

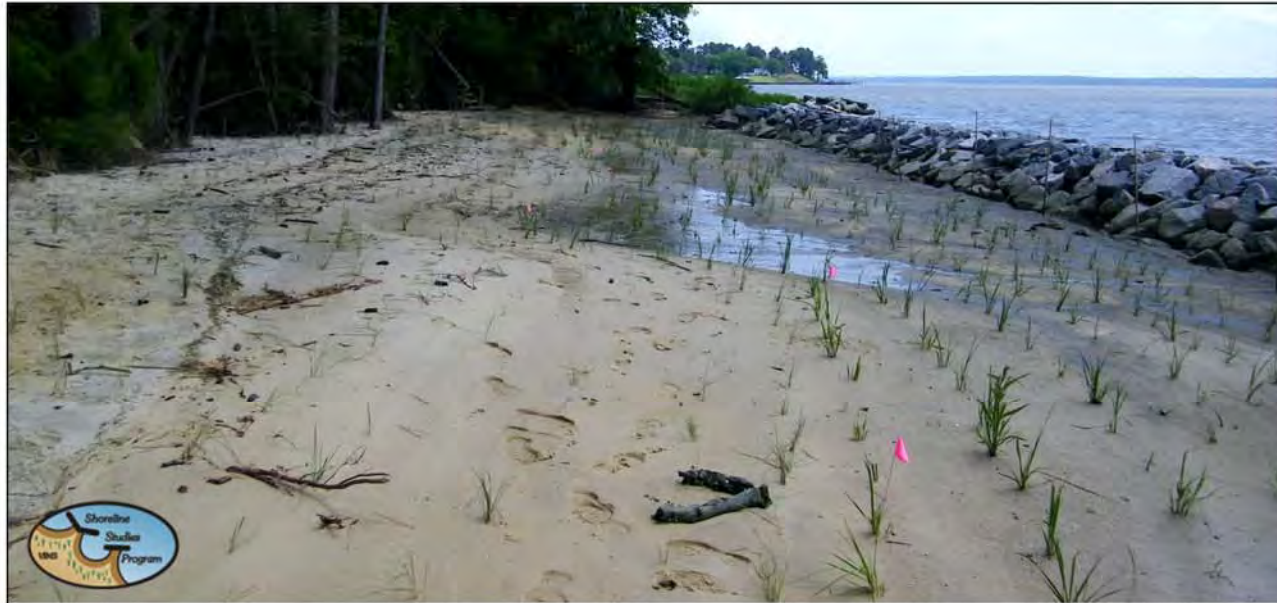
Marsh Sill

Stone structure placed near MLW

Backfilled with sand and planted with tidal wetland vegetation

- Stone
- Sand All 3 elements usually required for sustainable design
- Plants

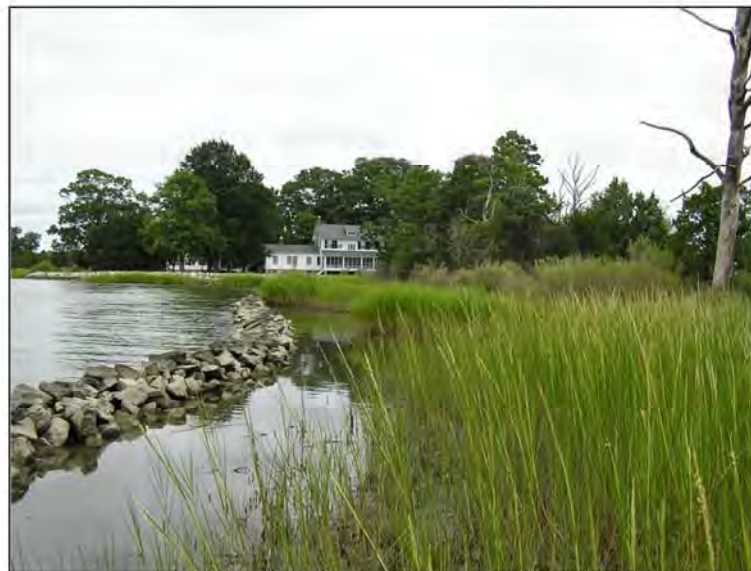
Marsh Toe Revetment

Sill placed next to an existing wide marsh.

Maintain desirable marsh ecosystem services.

Natural accretion depends on local sediment supply.

Can also spot fill and plant to fill in non-vegetated areas

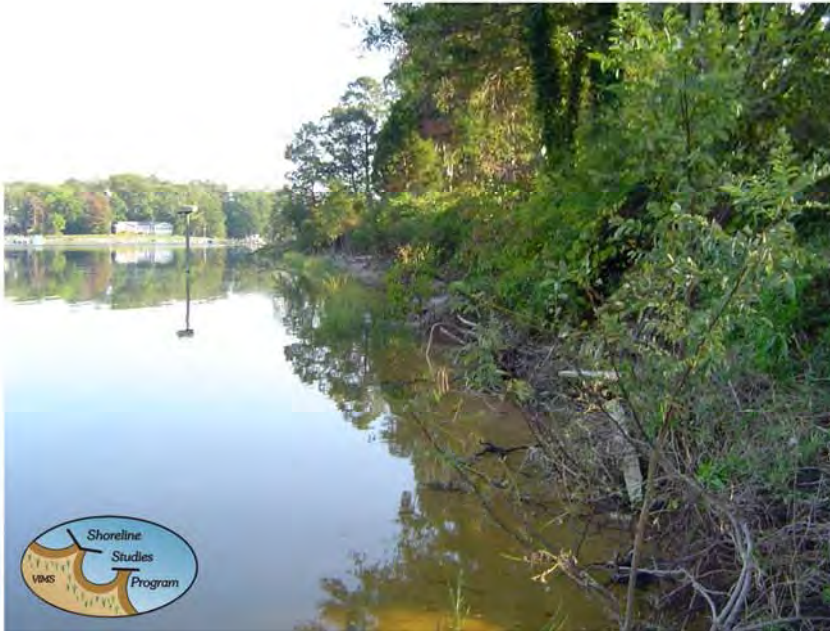
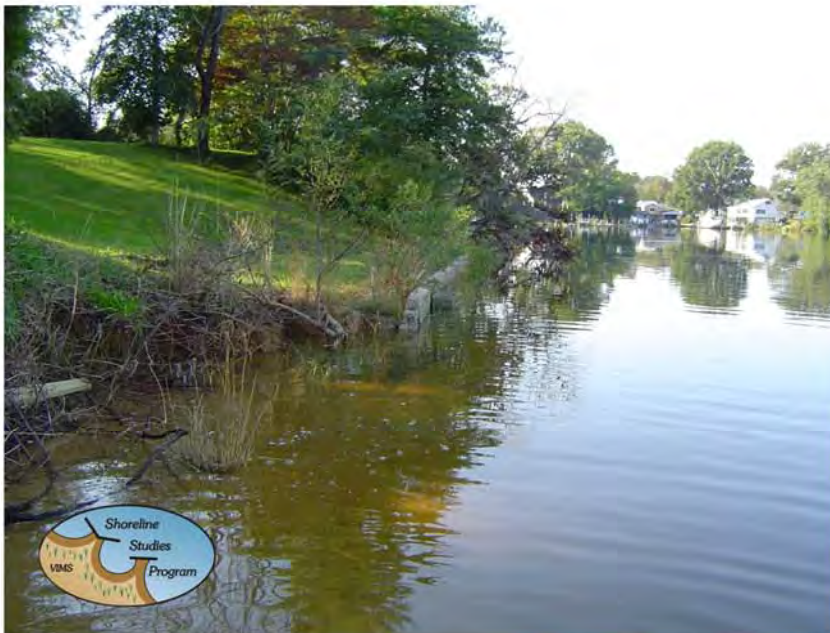
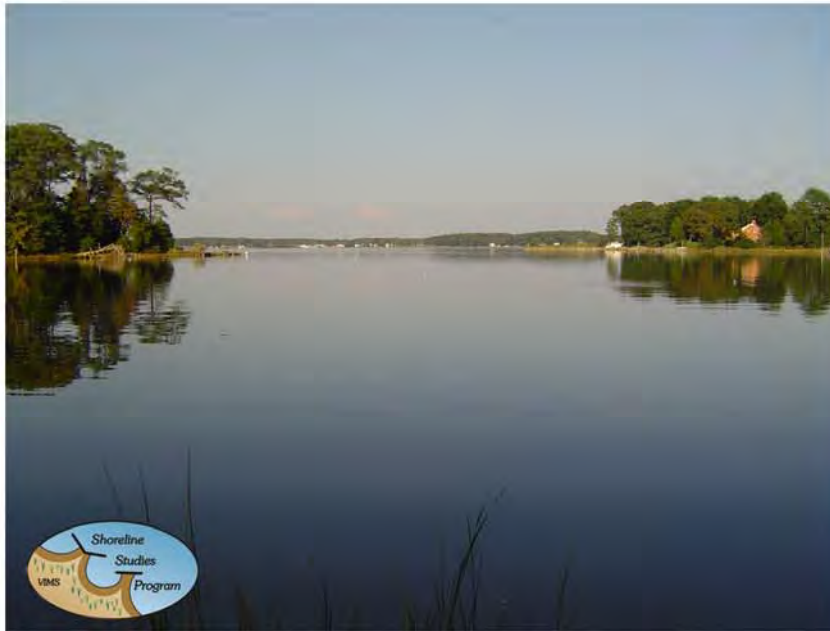
Hull Springs Farm Existing Conditions Before Project

- Level of protection needed underestimated
- Unstable bank disguised by dense vegetation cover
- Just one tree can limit options

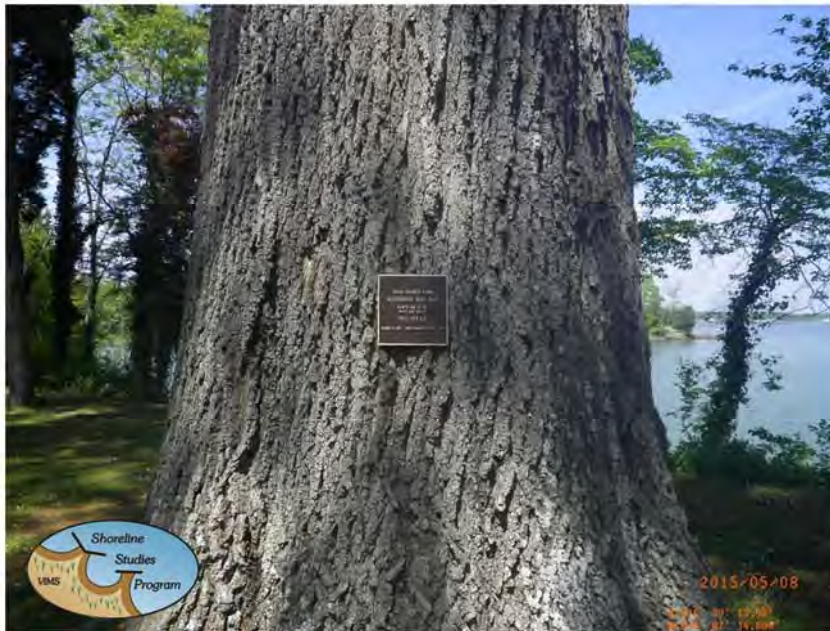
Historic tree that was threatened by erosion and needed to be preserved.

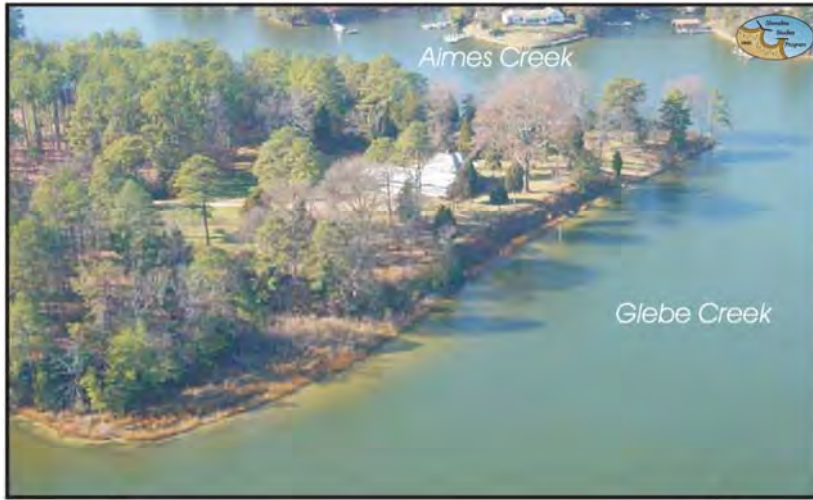
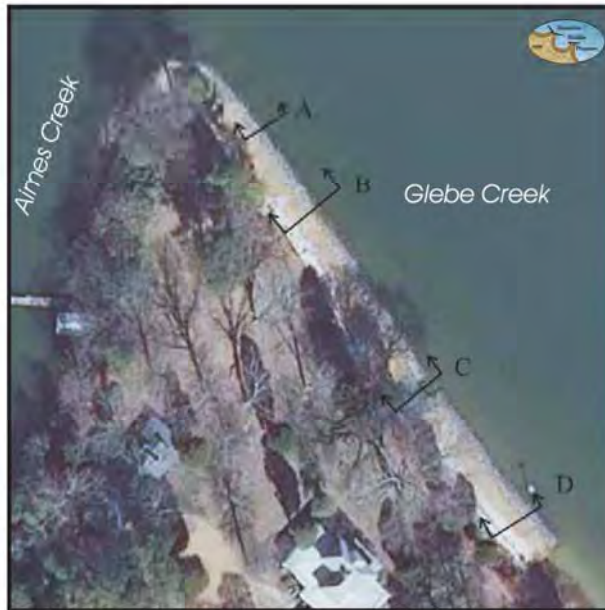
Hull Springs Farm

Top: Before the shoreline project, the bank is eroding in front of the Manor House.

Bottom: After the project, the shore zone was widened with sand behind the sills.

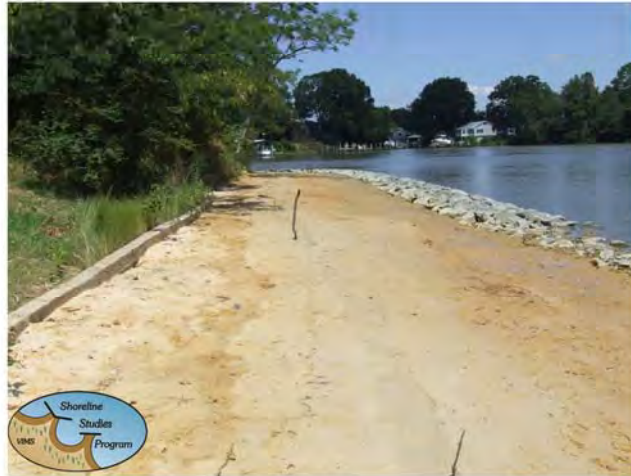
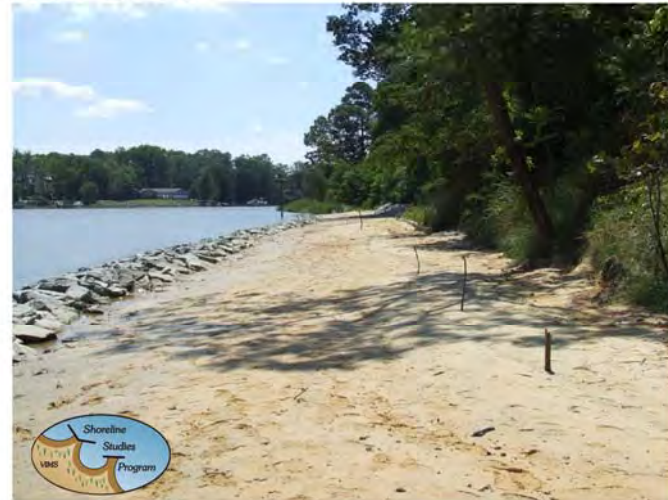
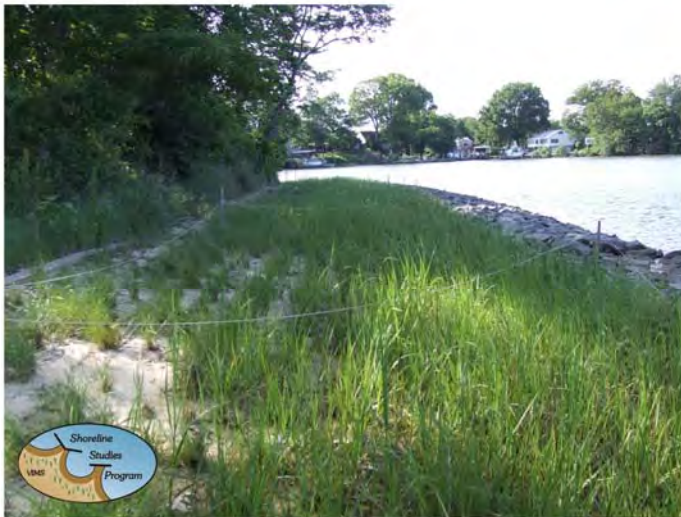
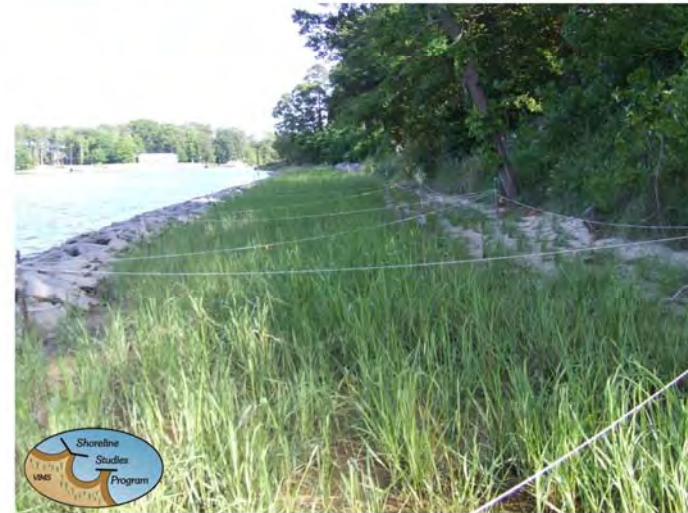
Hull Springs Farm Sill & Revetment

Post construction (pre-planting) and after 1 year.

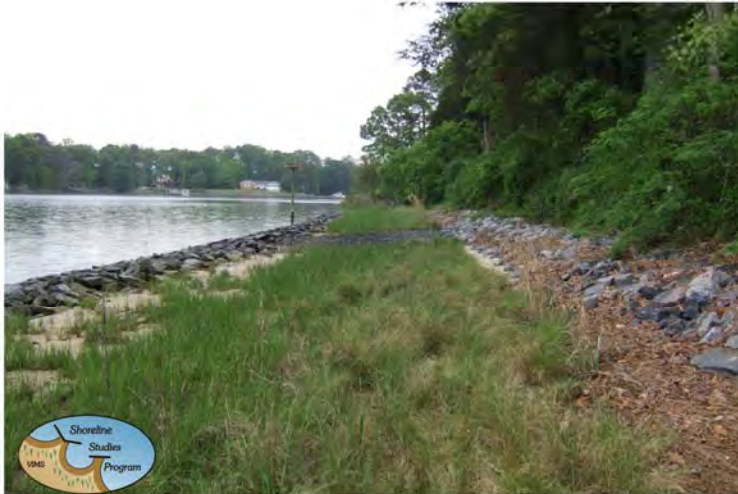
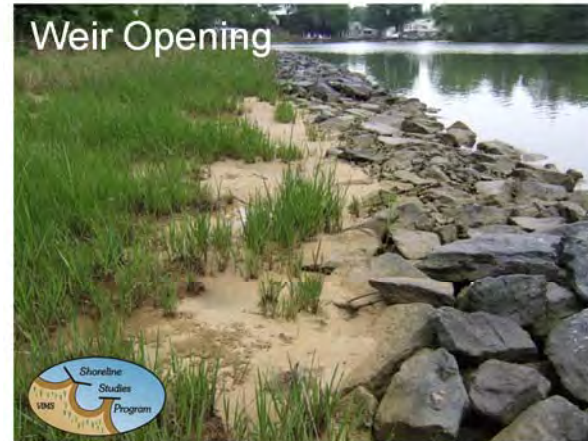
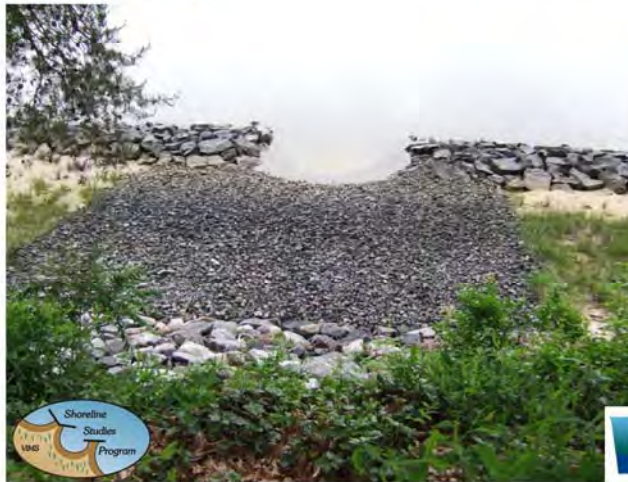
Hull Springs Farm Sill & Revetment

Two years after construction, the marsh grass is filling although some bare spots occurred. Also shown is the revetment that was built along the backshore for complete protection of the bank (Top Left) and the cobble window that was built in the system (Bottom).

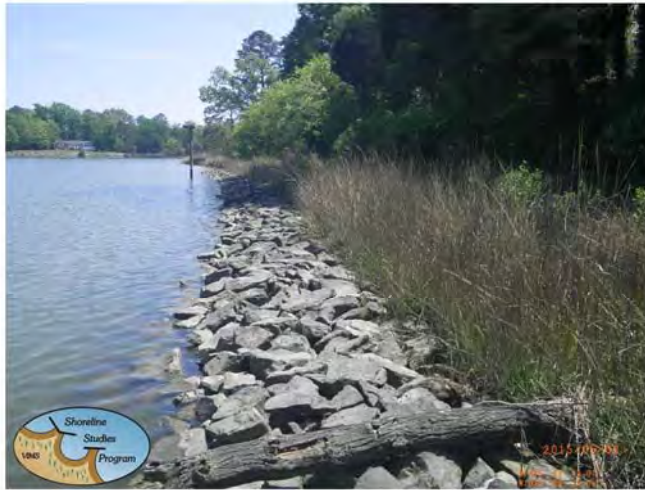
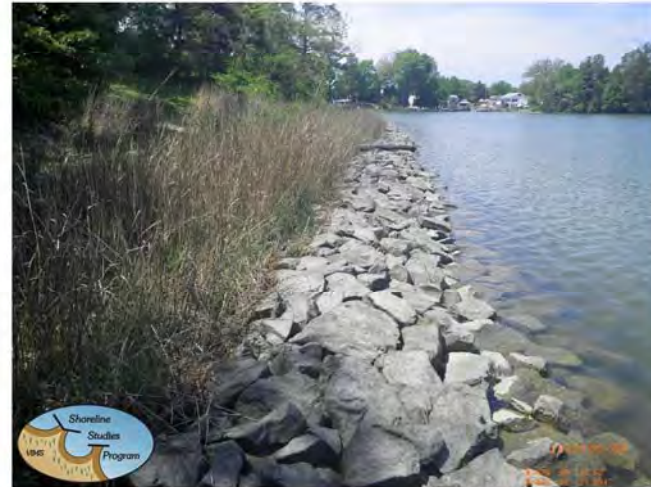
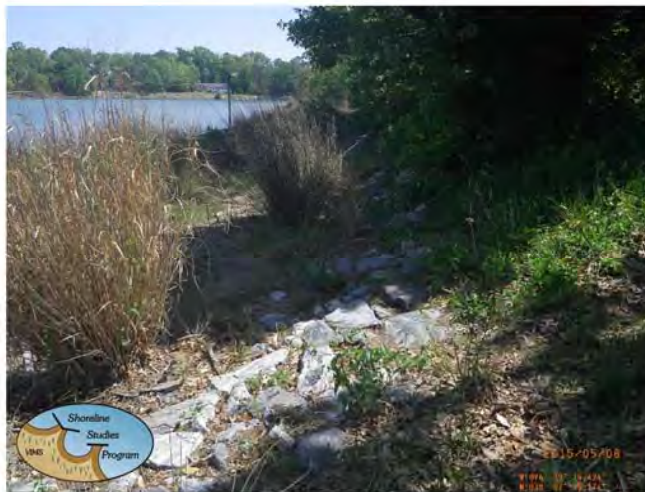
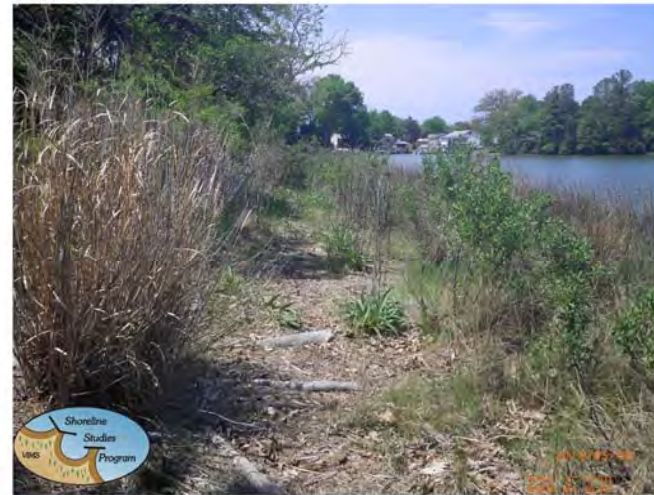
Hull Springs Farm After 7 Years

The marsh behind the sill has filled in over the 7 years post-project (Top). The backshore is being colonized by other types of vegetation (Bottom).
