**Living Shoreline Sea-Level Resiliency:
Performance and Adaptive Management of
Existing Sites
Summary Report**

Shoreline Studies Program
Virginia Institute of Marine Science
William & Mary

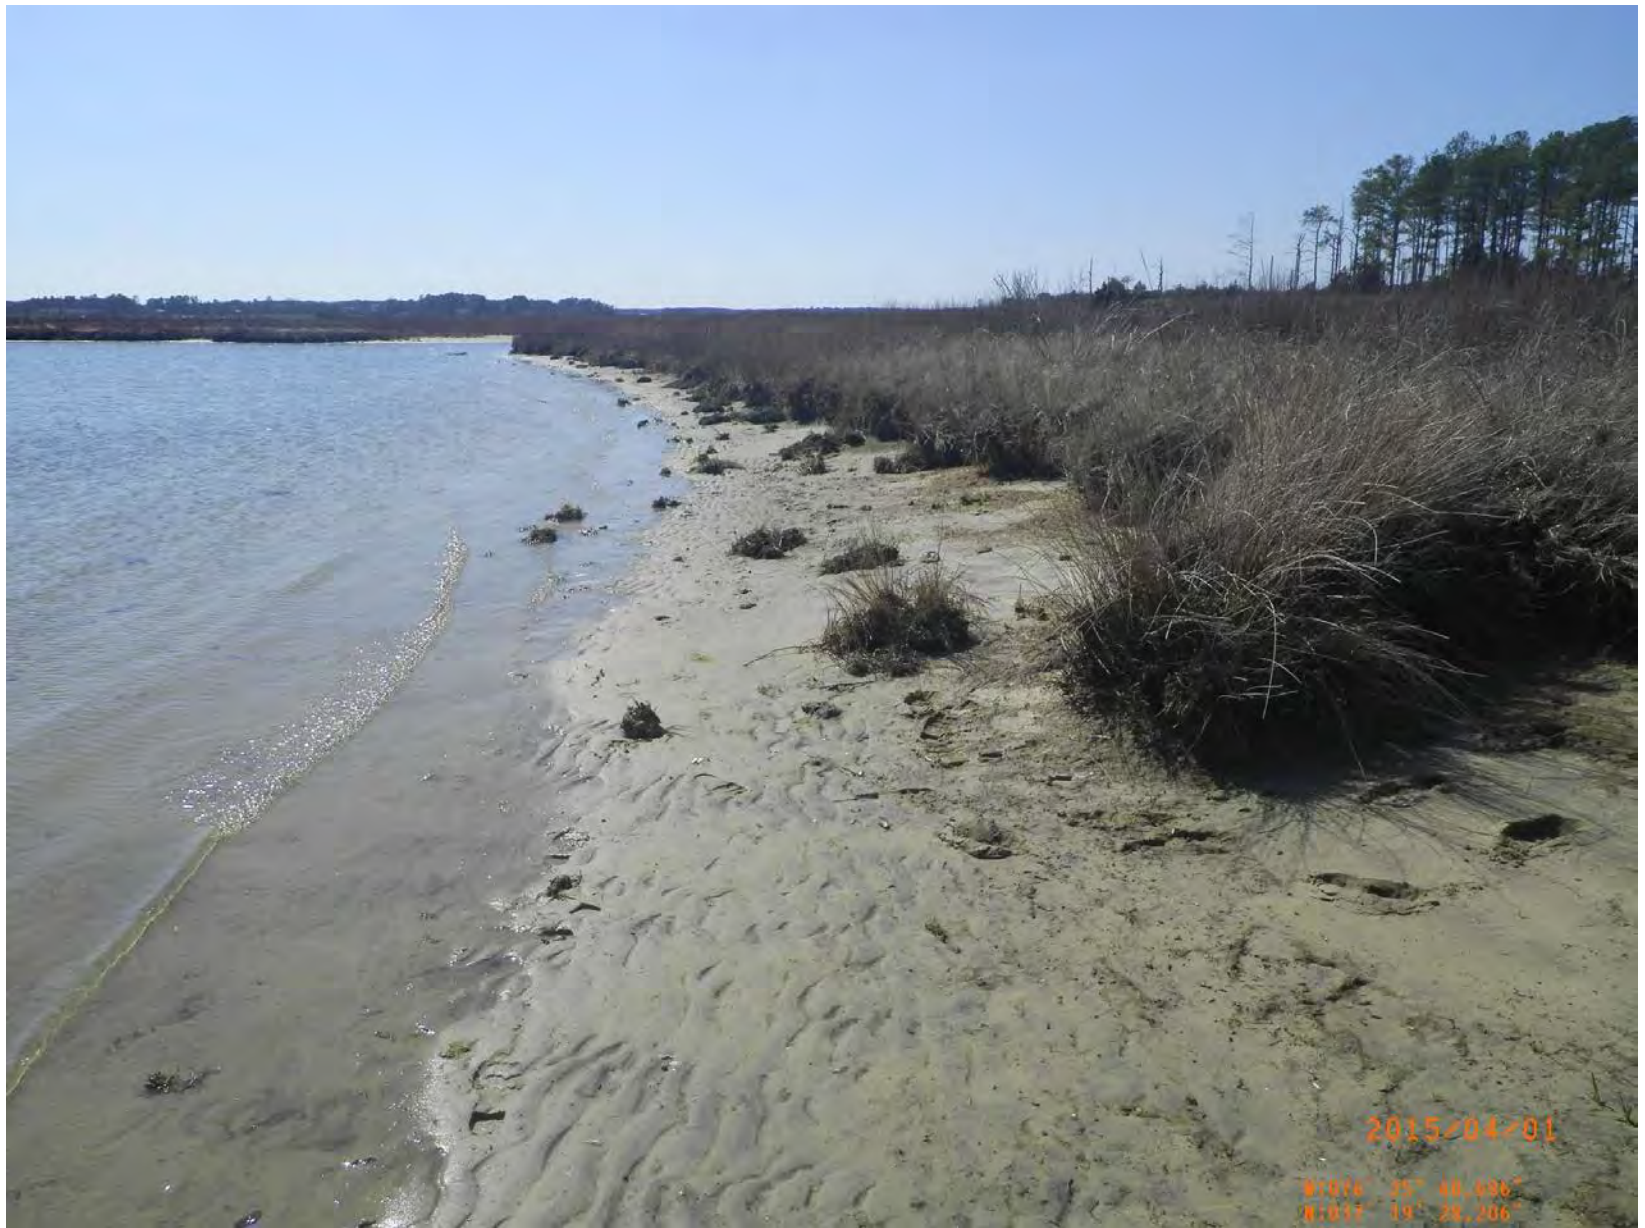
Conditions at Captain Sinclair before the project. Photo: Shoreline Studies Program, 1 April 2015.

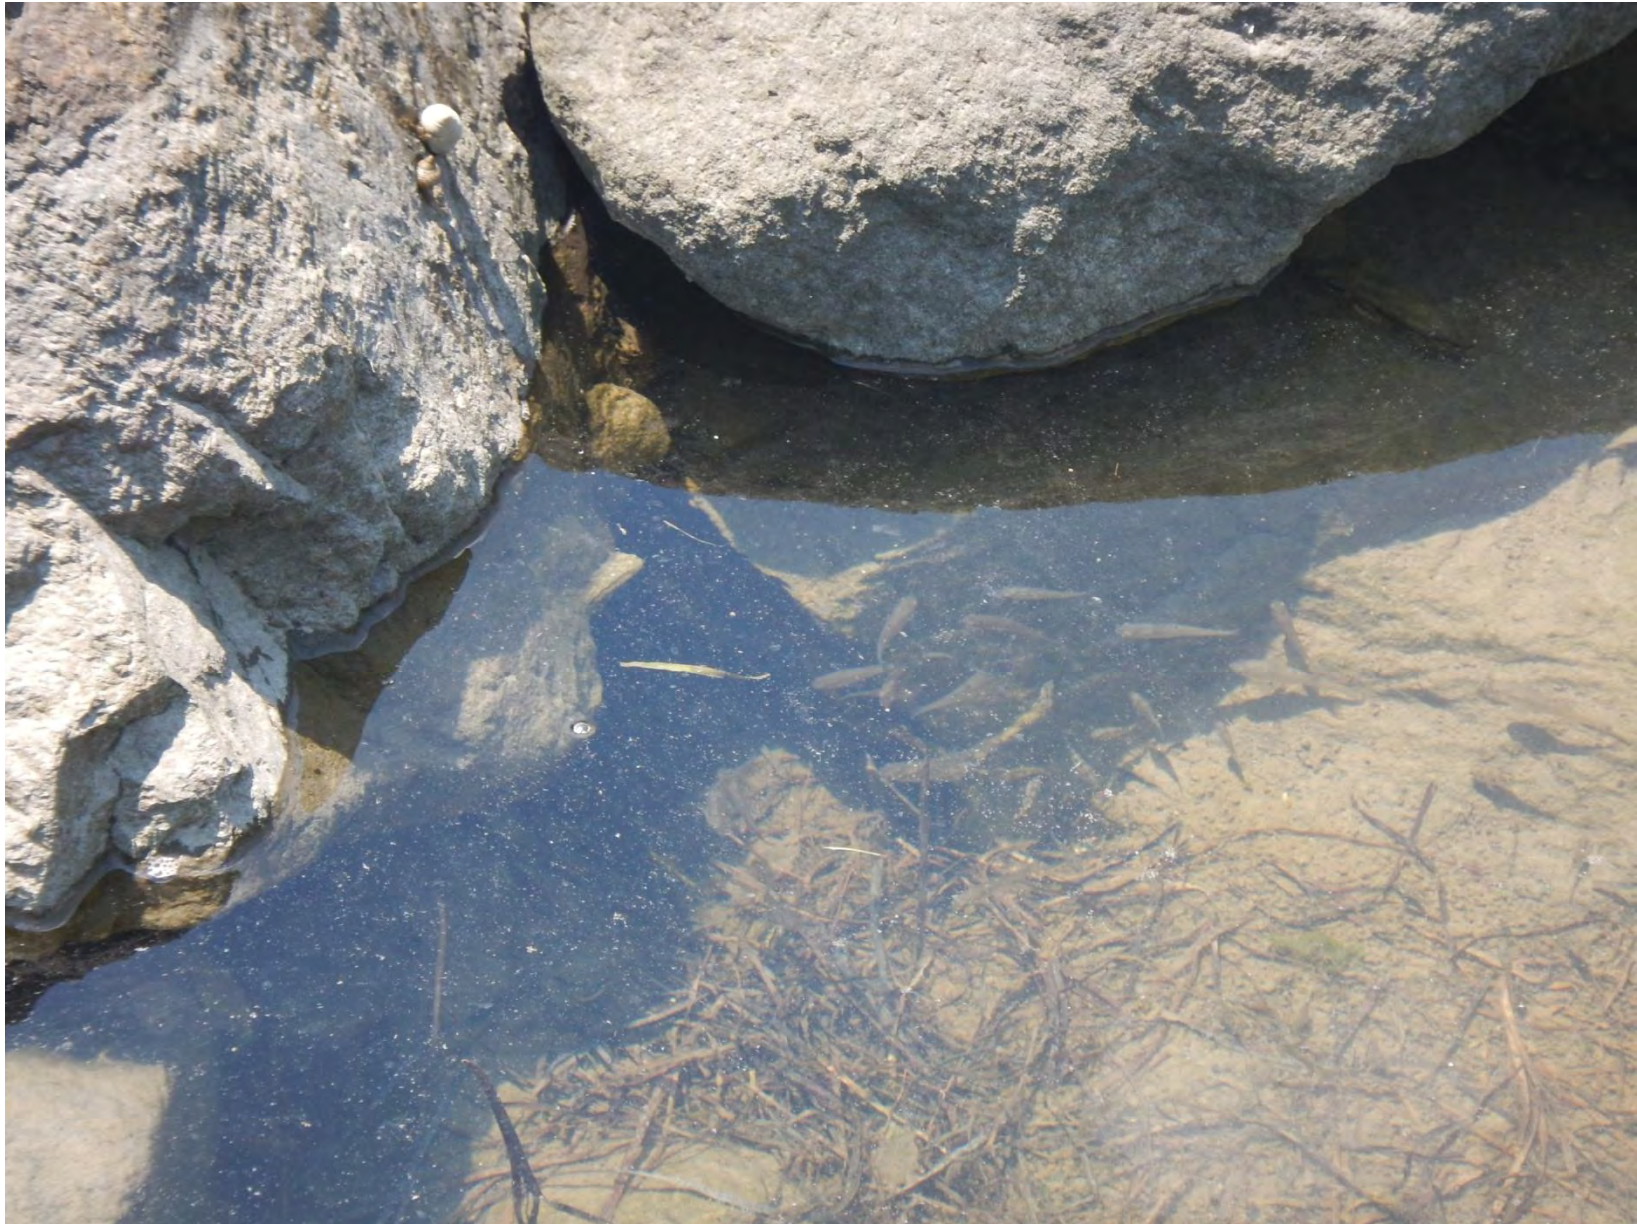
Oyster growth and small fish utilization along sill structures at high water
