**Living Shoreline Sea-Level Resiliency:
Performance and Adaptive Management of
Existing Sites
Summary Report**

Shoreline Studies Program
Virginia Institute of Marine Science
William & Mary

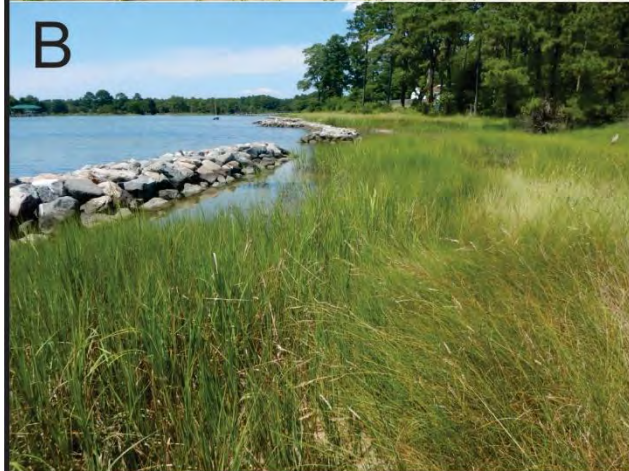
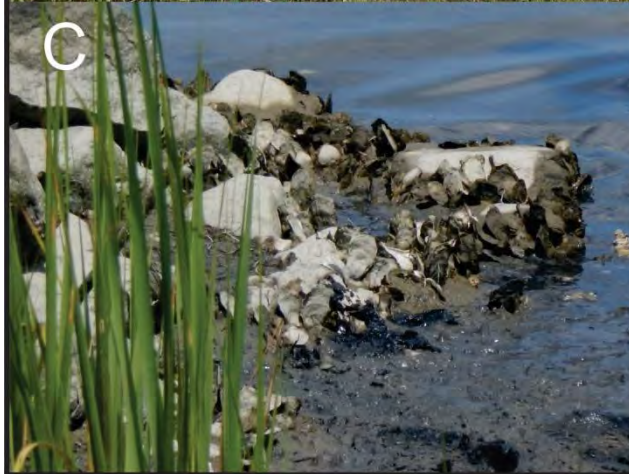
Photos of reach 2 at Occohannock on the Bay A) after planting (May 2013),

B) after 5 years(July 2018),

C) after 5 years there is abundant oyster growth around the end and outside of the rock sills.

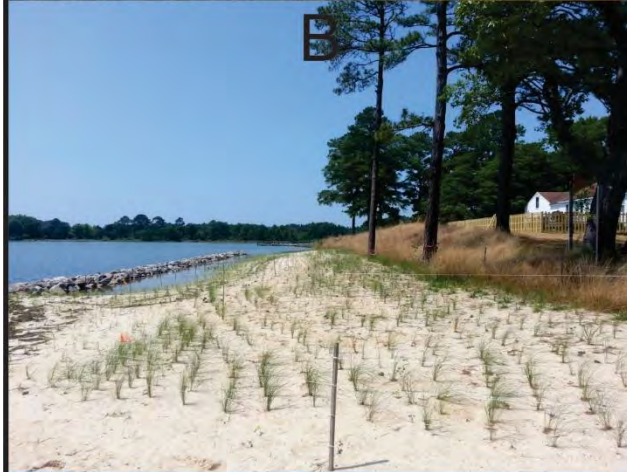
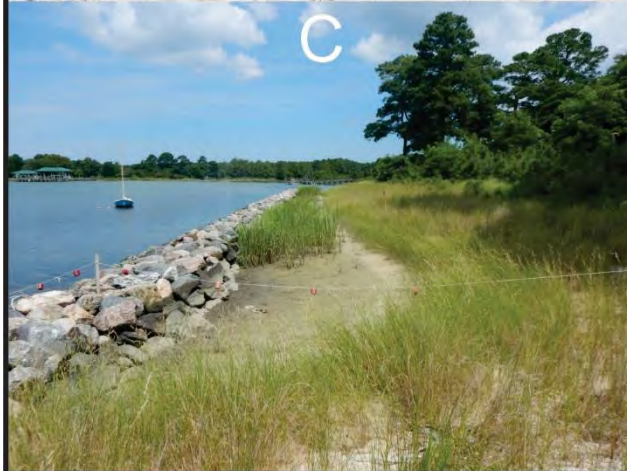
Photos of reach 3 at Occohannock on the Bay A), before construction (March 2013),

B) After planting (May 2013),

C) after 5 years.
